Direct Composite Restoration

CASE REPORT

By
Ahmed Saleh

Feb 2024

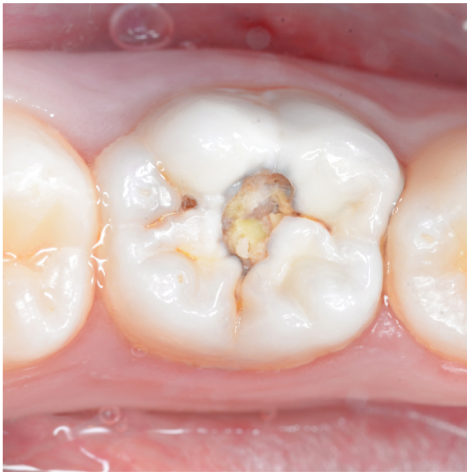
Fig.1

An occlusal preoperative view of existing Class II caries in tooth numbers 46.

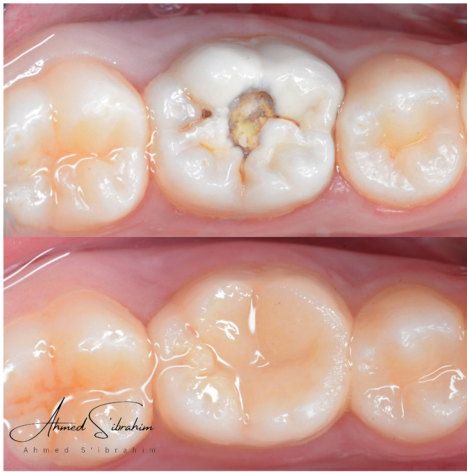
Fig.10

Before and after this picture was taken after two weeks.
