# RESTORATION OF DAMAGED ANTERIOR TEETH

CLINICAL CASE

**By**  
**Ali Hamid**  
Tokuyama Iraq Advisor

May 2024

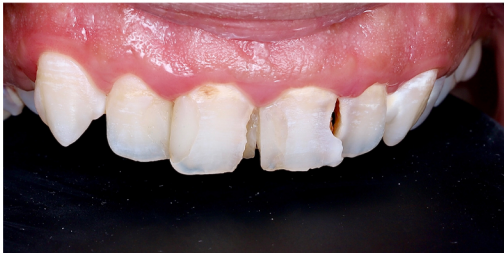
On examination it was noted that general dental health was not good , with existing of restoration , carious lesions and loss of periodontal attachment through gingivitis was diagnosed .

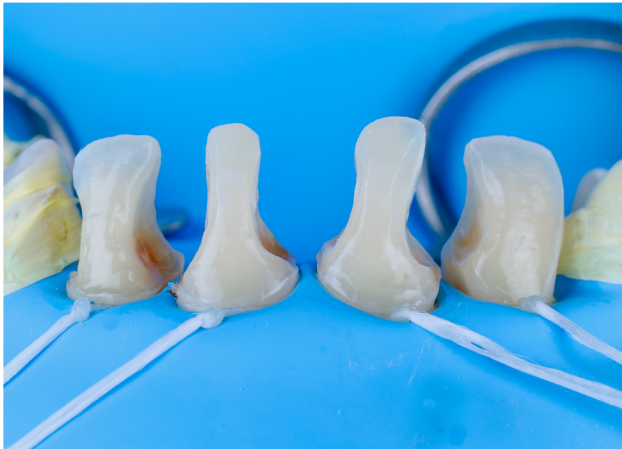
**Fig.2**

Bonding

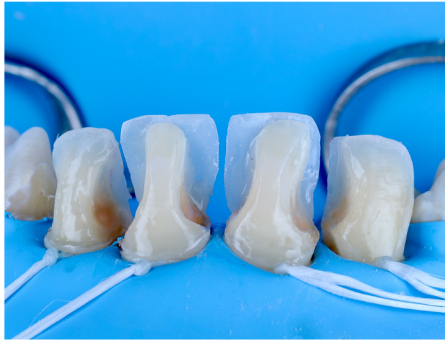
**Fig.3**  
Palatal shell by Ce shade using silicone index

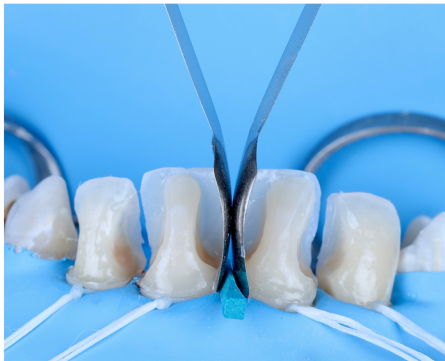
**Fig.4**  
Using sectional band (shovel type) to build the proximal walls

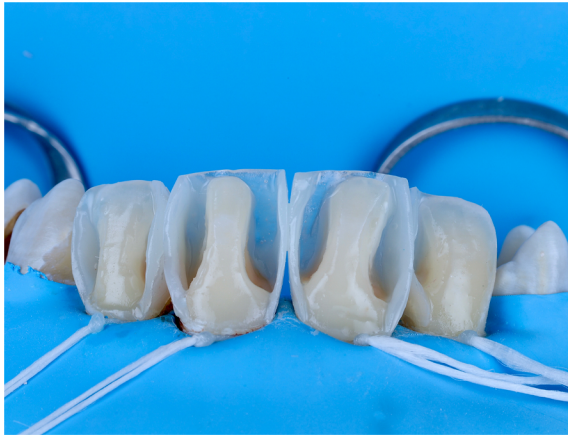
**Fig.5**  
Proximal wall by We shade

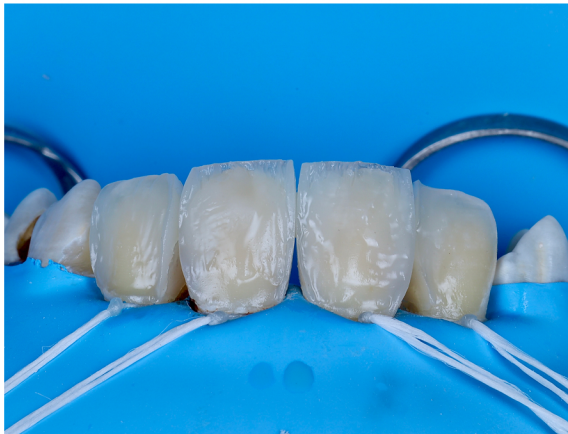
**Fig.6**

Using Opa2 & Oa1 as a dentine , this shade have adequate opacity designed for blocking out the dark shine that comes through oral cavity

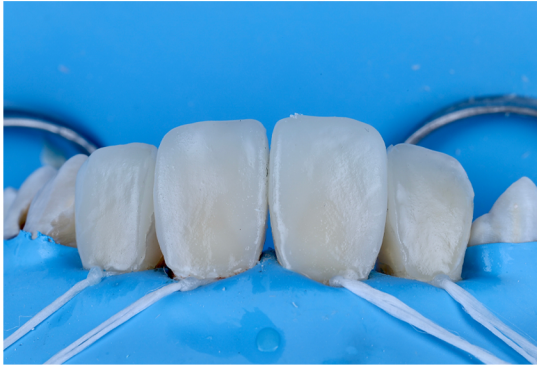
**Fig.7**  
Using We shade as a final layer

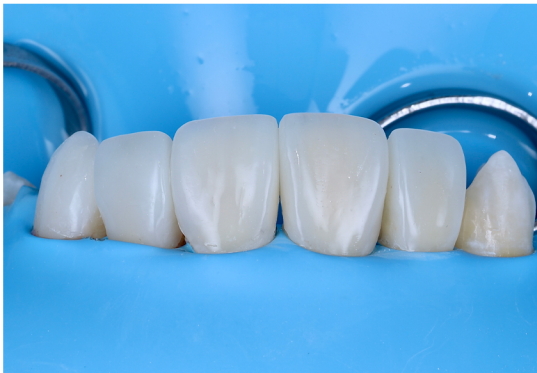
**Fig.8**  
After finishing & polishing

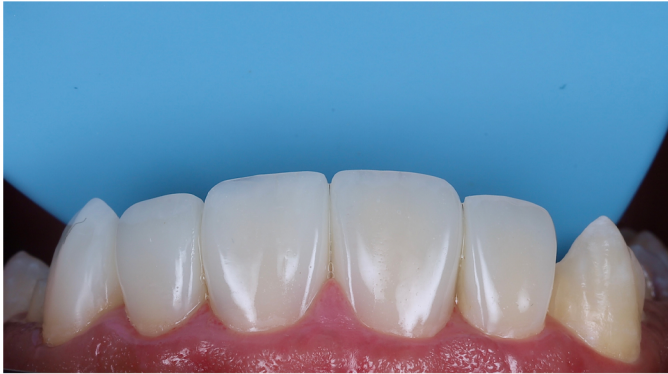
**Fig.9**

This Photo captured after 4 months of treatment .

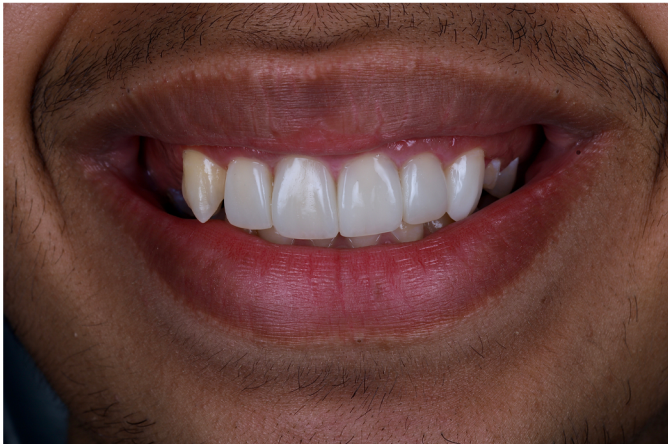
**Fig.10**

Extra oral photo

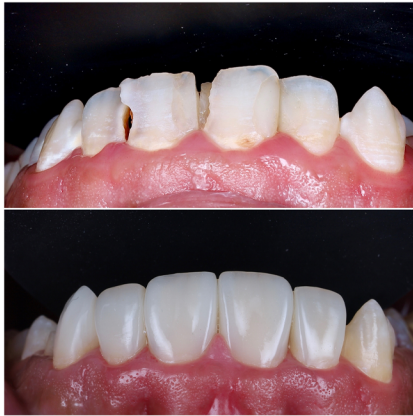
**Fig.11**

Capture Before & after images to show the transformation achieved with the restoration
